Horsfall Tunnel, Todmorden: The design, construction and performance of a temporary reticulated mini-pile retaining wall.

This paper presents the design, construction and performance of the temporary reticulated mini-pile wall designed and constructed by Kvaerner Cementation Foundations. Ove Arup & Partners were appointed as independent checker.

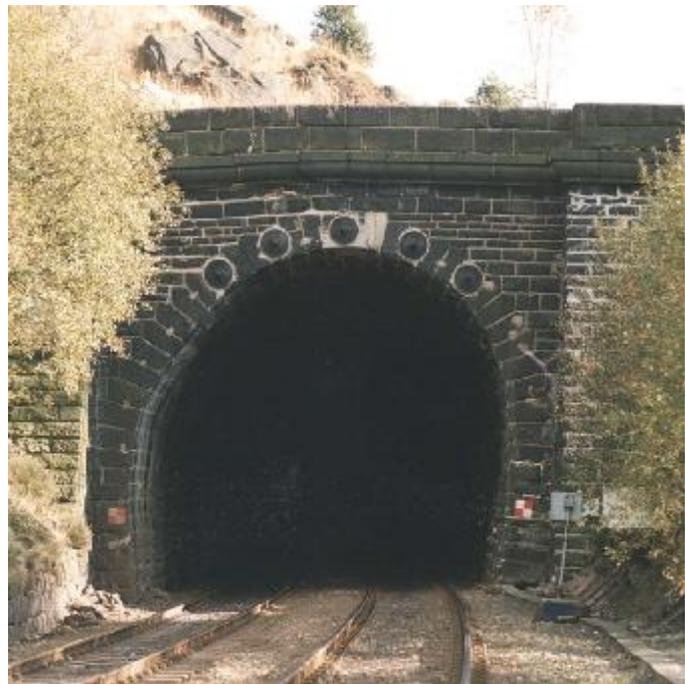
Figure 1: The west portal before the start of site works

Railtrack maintain over five thousand bridges, tunnels, and earth retaining structures in the North West of England, most of which were designed and built during the mid to late nineteenth century. Horsfall Tunnel is one such structure located between Todmorden and Hebden Bridge on the Manchester to Normanton Trans-Pennine express route. The tunnel was built between 1837 and 1840 and has a long history of movement confirmed by recent monitoring showing deflections of up to 3mm per annum. A 40 mph speed restriction had been in place for some time and visual inspections near to the west portal indicated the tunnel to be increasingly intolerant of further movement and in danger of structural failure (Figure 1).

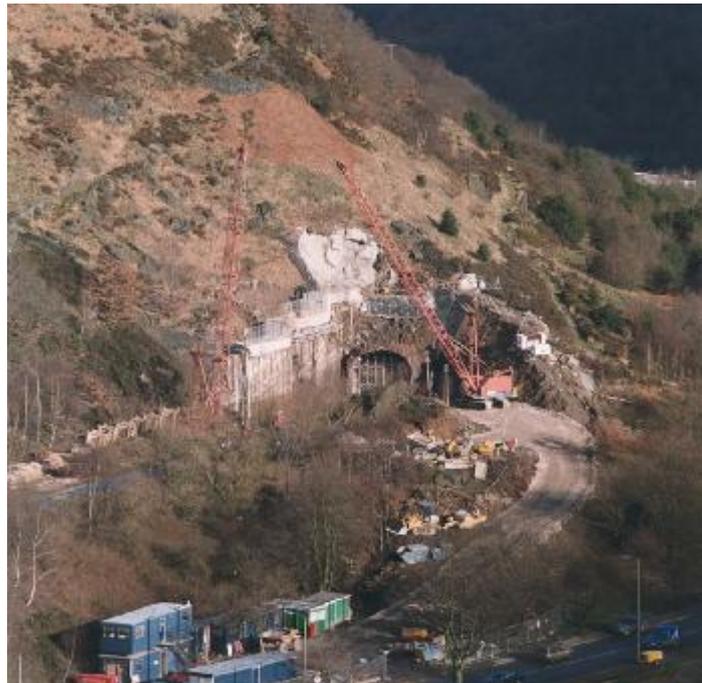
Figure 3 : A panoramic view of the site during construction

area and geological setting renowned for slope failures (Figure 3). In order to place the published geology and site investigation records into full context, a geomorphological assessment was undertaken of the area surrounding the site using available aerial photographs.

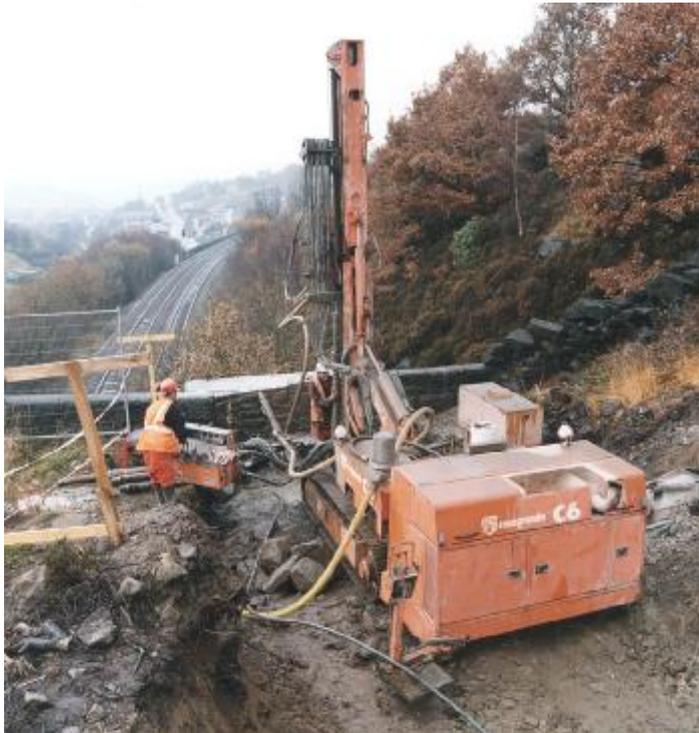
Figure 5 : Casagrande "C6" rig operating above the tunnel

Originally it had been planned to use four Casagrande "C6" drilling rigs but it quickly became apparent that this would not be practical nor cost effective in such a small restricted site. The area directly above the tunnel had a weight restriction of four tonnes which severely restricted the movements of the "C6" drill rigs weighing around 12 tonnes. It was therefore decided to work two drill rigs for two shifts each day. Consequently the minipile installation works were ongoing from 6 a.m. to midnight throughout Monday to Friday (Figure 5).

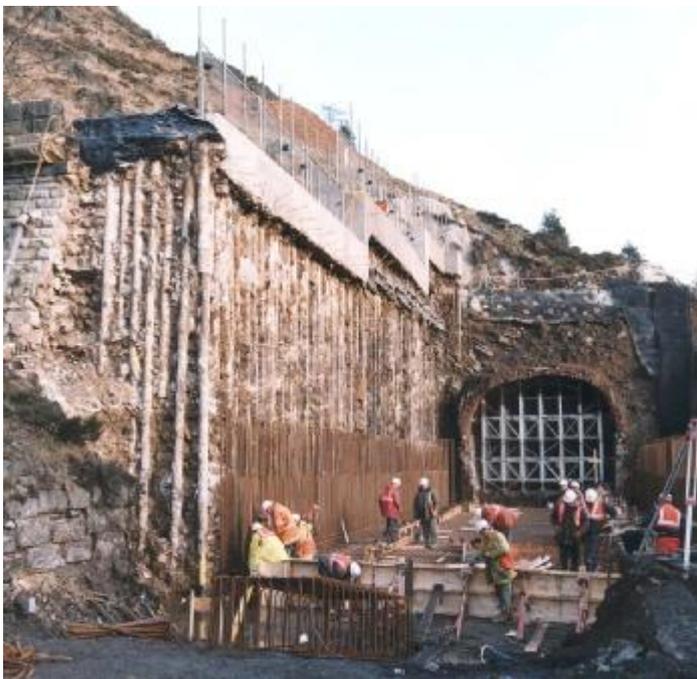
Figure 6: A view of the wall shortly after demolition of the tunnel

were successfully installed in advance of the demolition which commenced on 19 Jan 1998 (Fig 6).

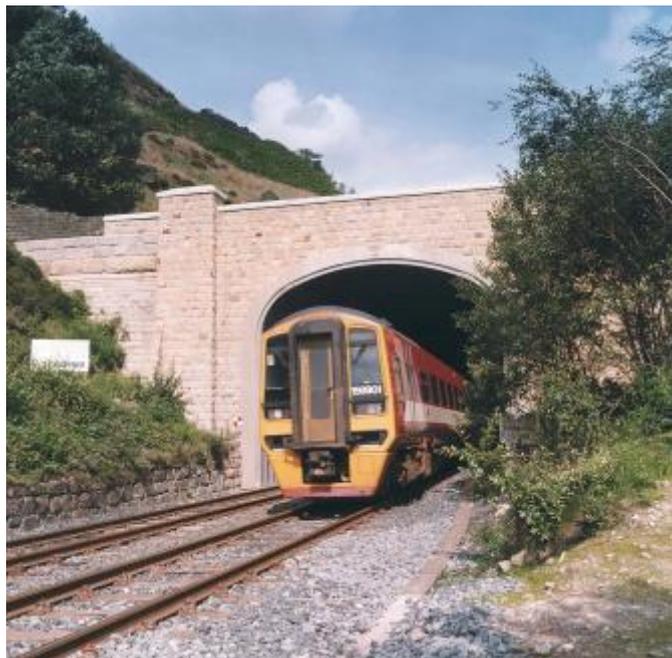
Figure 8 : The re-instated tunnel in operation

As the result of these works, Railtrack have been able to restore the full line speed of 70 mph with the associated benefits to the travelling public (Figure 8). The project has also provided the opportunity to solve a technically challenging problem using the latest drilling technology and an established, although uncommon technique, to retain substantial wall heights where the more conventional alternatives have been ruled out. The overall project success was acknowledged when the project won the 1999 ICE Yorkshire Association award for excellence in concept, design and execution of Civil Engineering works. A plaque was unveiled at the site on 26 March 1999 by the President of the Institution of Civil Engineers.
