CANNON STATION REDEVELOPMENT, LONDON

This paper discusses the geotechnical challenges overcome in providing the foundations for the Cannon Station Redevelopment, London. The original Station was constructed 150 years ago as a brick arch viaduct with an iron roof and has been substantially modified during its life. The present £350 million scheme dates back to 1995 and comprises major demolition works and the construction of a new steel framed office building with retail units, all supported on new columns which pass through the existing viaduct. The northern columns reuse the existing under-ream piles, supplemented by new settlement reducing piles. The southern columns found on novel micropile groups within the arches and on new under-ream and large diameter piles to the east where headroom is available. The micropile groups provide a safe and cost effective alternative to traditional hand-dug caissons with less impact on the important roman archaeology. This paper describes the foundation scheme, the preliminary test pile programme and the site works.

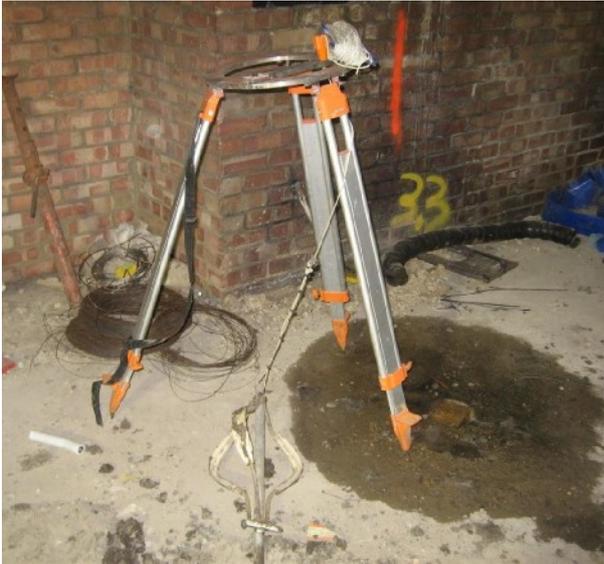
Figure 5 – Support Frame and Centralising Bracket

back into tension) to prevent them being forced into the ground and going off the vertical. This meant that the augers were 'hanging' vertical, similar to a 'plumb bob', immediately prior to each short boring cycle. Boring became progressively slower below 20m depth and extra care was required over the final few metres when there was a considerable weight of augers in the bore. Excellent verticality was achieved and the bases of the micropiles were clearly visible when a bright light was shone down the bore. In view of the importance of good verticality for the group design, a simple method of checking and validating the micropile verticality was developed (See Figure 5). This comprised of hanging a centralising bracket (spider) in the base of the bore via a fine cable from piling platform level (PPL). The cable was then plumbed vertical using a steel support frame and a 1.2m spirit level. Finally, the distance from the centre of the pile casing at PPL to the plumbed cable was measured (northing and easting). The pile verticality was then simply calculated by dividing the pile depth by the recorded measurements. This method relies on the cable not touching the sides which must be visually checked by shining a light down the bore. The maximum out of vertical tolerance is therefore equal to half of the pile diameter, i.e. 150mm over 25,000mm or approximately 1 in 166. If the cable did touch the side, then the depth of the spider would be recorded and the verticality interpolated to the full depth (i.e. assuming that the pile carried on at the same inclination). This only happened on three occasions.

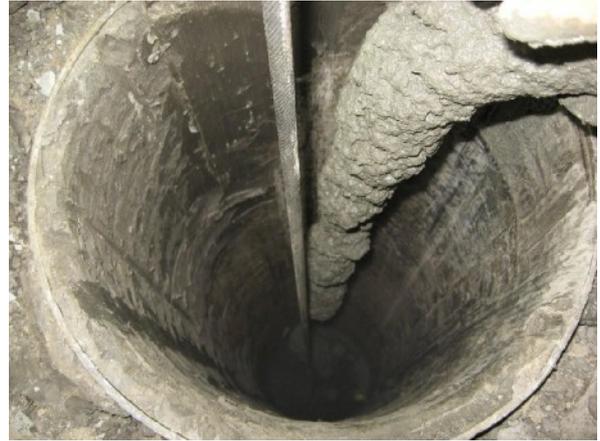
Figure 6 – Concreting of micropile

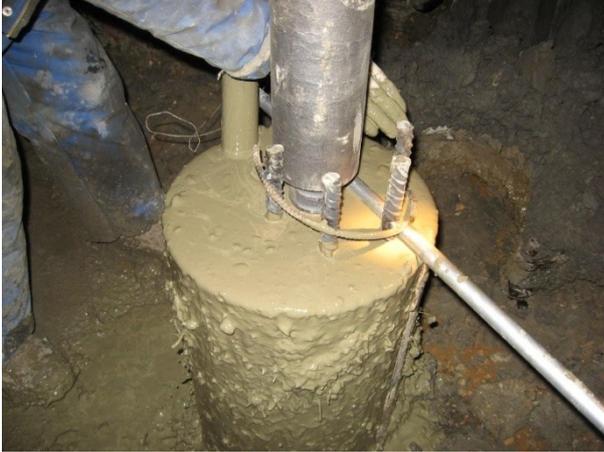
Figure 8 – Grouting of micropile (debris being flushed out)

The average grouting time was 2.0 hours (22 batches per micropile) with an over break of 20 to 30%, which is typical for this type of pile. The grout was pumped into the base of pile bore until any debris was flushed out and it was completely

full of clean grout (see Figure 8). The central 63mm diameter rebar was inserted prior to grouting due to concerns over the grout setting quickly at the base and preventing installation of the rebar. An additional (6 x H20) reinforcement cage was again incorporated over the critical upper section of the pile.

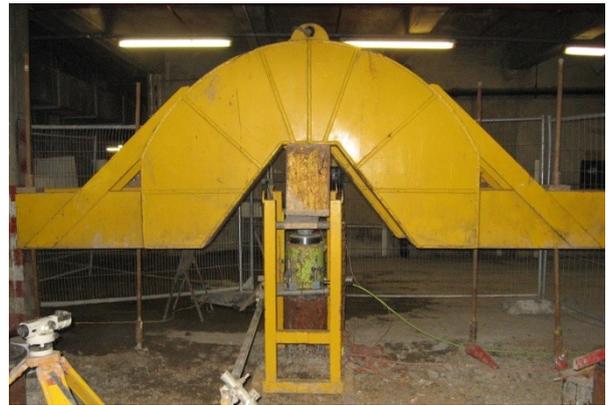
Figure 9 – Static Test Pile Reaction Framework

Precision Monitoring and Control Limited carried out the static pile tests and Testconsult Limited carried out the dynamic testing, generally in accordance with the ICE Piling Specification. All testing was undertaken between 18 and 46 days after micropile construction. Dynamic tests were carried out before and after the static test on TP1. The definition of pile ultimate capacity was agreed to be equal to the required applied vertical force to develop 30mm of pile head settlement. The static test pile reaction framework is shown in Figure 9 and the results summarised in Figure 10.

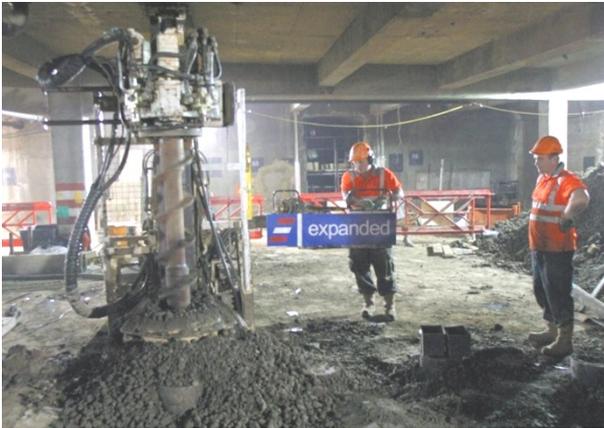
Figure 13 – Micropile boring using nominal 300mm diameter augers

A total of 190No micropiles (75%) were installed during phase 1 between June and November 2008 using an electric Klemm 702 drill rig and a diesel Hutte 202 drill rig with 2.2m masts (see Figure 13). The electric drill rig was preferable because it did not produce fumes in the restricted basement areas. This total included 36No micropiles for tower crane bases. The majority of the minipiling works is in an archaeology sensitive area or alongside known remains. In preparing the ground for the micropile groups it was necessary to

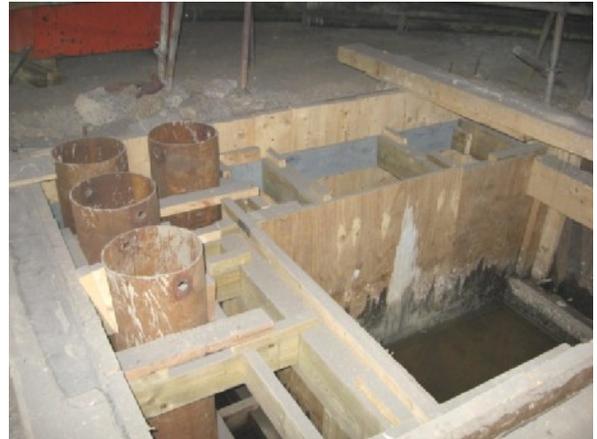
Figure 14 – Thin walled expendable steel casing

carefully excavate and record the archaeology to natural ground level. The method adopted is to accurately position steel casings into timbered excavations through which the micropiles are installed. The archaeology is protected by impervious sheeting, fibreboard and a suitable geotextile. These enabling works were undertaken by a separate contractor under guidance from the Museum of London Archaeology (MoLAS). The steel casings extended down to the London Clay and were sealed into position with a cement bentonite grout. The steel casings provided several advantages:

The steel casings therefore removed considerable drilling risk for Expanded Piling Limited (EPL), with only 'simple' open-hole auger drilling remaining in the London Clay. It was possible to use concrete in all of the micropiles, which allowed the concrete level to be left 2 to 3m below piling platform level (PPL), leaving a minimum of 1.0m above COL. In approximately 40% of the micropile locations there was sufficient headroom and continuous thin walled expendable steel liners were used (see Figure 14). In the remaining locations where there was restricted headroom, standard segmental temporary drill casing was used. The drill rig would 'break' the temporary casing seal with the cement bentonite grout after the concreting of the pile and then remove and reuse the casing. There was a complicated logistical exercise to obtain the maximum reuse of the temporary segmental casing, and prevent the site becoming congested with casings.

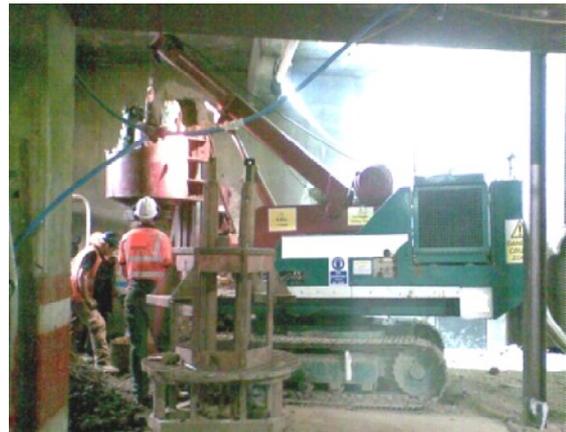
Figure 15 – Low headroom piling rig & crane

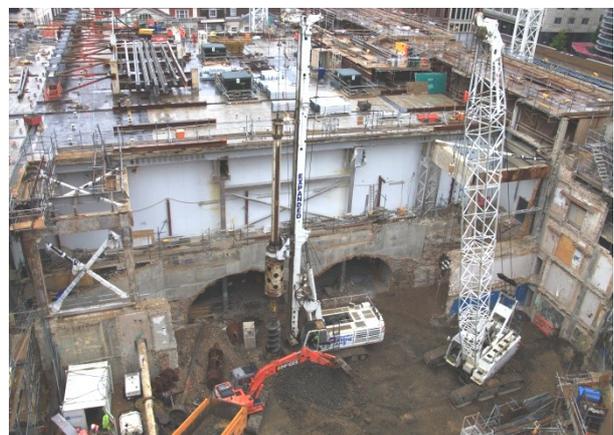
Figure 16 – Restricted Western Site layout

In the southern half of the development the new columns are founded on 11No micropile groups to the east and 11No underream and straight shafted piles to the west. These comprised of 7 No x 1,500mm diameter piles with 3,900mm underreams and 2No x 1,200mm diameter piles with 2,300mm underreams, up to 31m deep. During June 2009 a large 95 tonne hydraulic rotary rig was delivered to site with a 70 tonne attendant crawler crane. Although the piling area had no headroom restrictions the limited plan area, tight access and proximity of network rail infrastructure required detailed logistic and pile construction sequencing (see Figure 16). This was compounded by the presence of claystone bands at various depths within the shaft and in the underream itself. Due to this issue and previous problems other contractors have had constructing underreams in this area of London the decision was take not to remove any spoil from site until the concreting process was under way. The underream piles took up to 80m³ of concrete and generated up to 150 m³ of bulked spoil (see Figure 17).

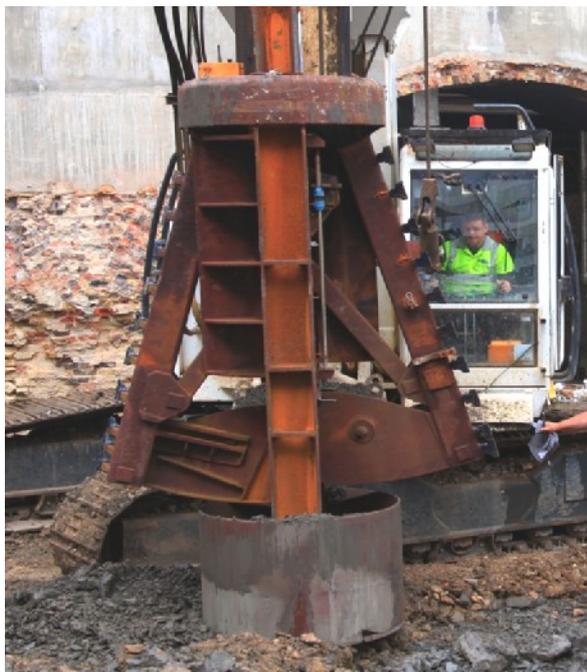
Figure 17 – Underream Tool

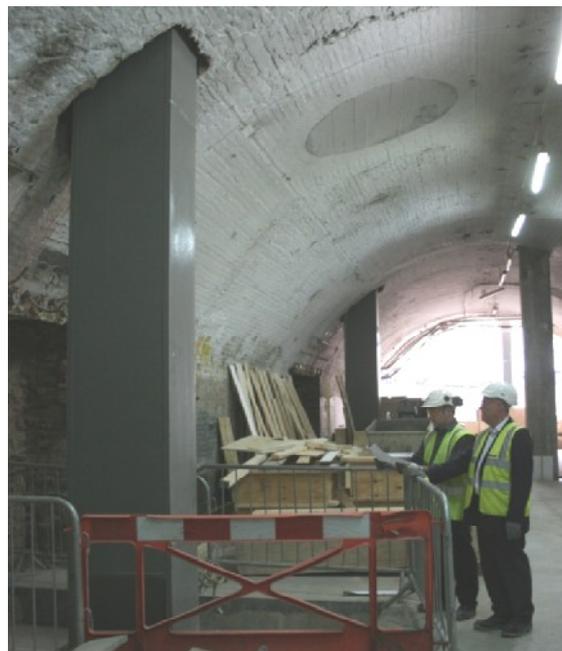
Figure 18 – New Columns on Micropile Bases

Testing and analysis have demonstrated the feasibility of using micropile groups in restricted headroom to support column loadings of up to 18MN at Cannon Place, London (see Figure 18). This innovative solution has several advantages over large hand dug caissons that would have been the only viable alternative. The pile test analyses conclude that an α -value (adhesion factor) of 0.4 for long slender micropiles in London Clay should be adopted. Excellent verticality's of ~1 in 580 (average) are achievable when care is taken during drilling, in conjunction with vertical steel guide tubes. The use of pumped concrete produces a stiffer pile, with associated cost, programme and environmental advantages. Dynamic pile tests provide a useful and cost effective method of validating micropiles in restricted headroom, where the dynamic test has
